Home Inspection Report

12099 E Louisiana Ave., Aurora, CO 80012

Saturday, October 26, 2019

Seamless Home Inspection, LLC

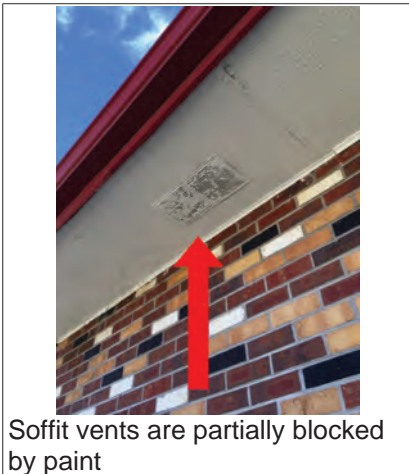
Soffit vents are partially blocked with paint. Recommend cleaning vents to allow proper venting. See photo.

Soffit vents are partially blocked by paint

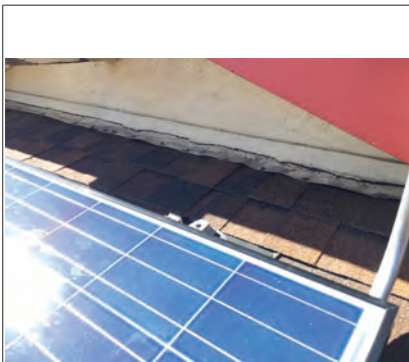
The roof flashing has pulled away from the roof - recommend a licensed roofer repair.

East side flashing is separating from roof

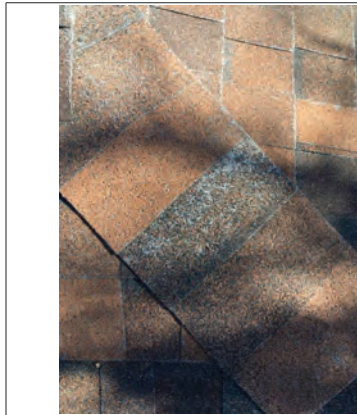
One nail pop was observed and shingles are beginning to show signs of granule loss.

Granules missing from ridge caps

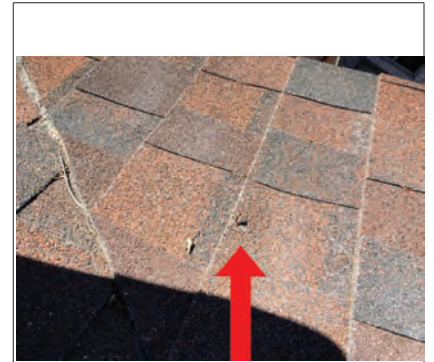
Nail pop observed

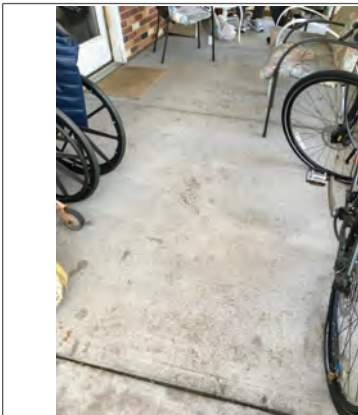
Patio

Handrail on the south side of service walk to patio is loose. Potential safety hazard. Recommend repair.

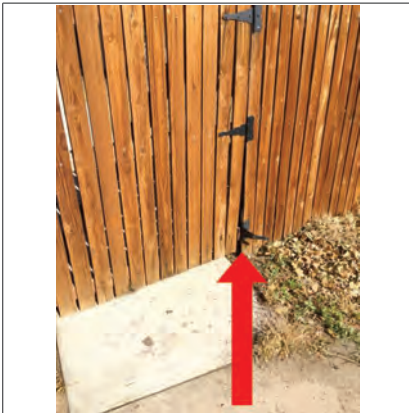
- East gate may be operational but has damaged hinges. Repair as needed. West gate was operational.
- Fencing was in need of maintenance repairs. Repair as needed.

East gate hinge is damaged/loose

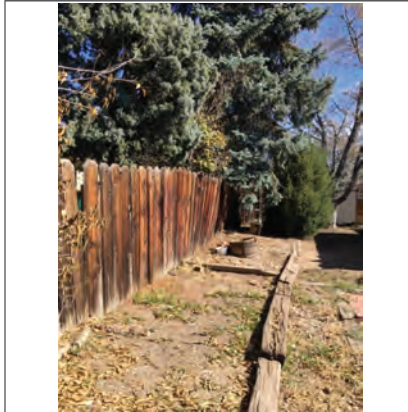
Leaning fence in back yard

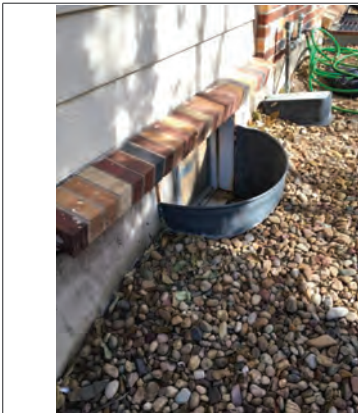
Recommend installing window well covers. Adding window well covers will help prevent moisture and debris from entering the window wells. In addition, an open window well is a falling hazard.

Missing window well covers and negative grading

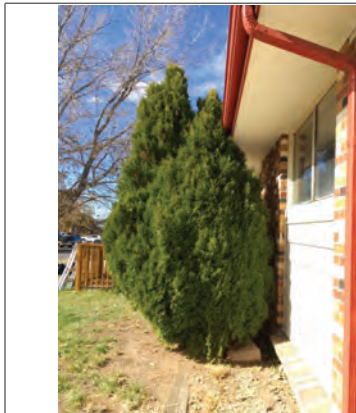
Recommend trimming trees back from home

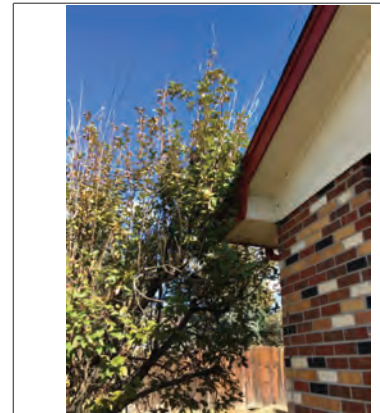
Recommend trimming trees back from home

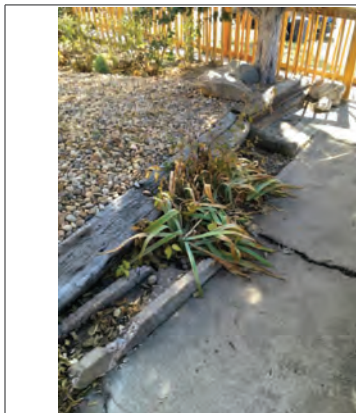
The retaining wall(s) are made using wood timbers. The timbers are deteriorating. Recommended replacing rotten timbers and fortifying the wall as needed.

Deteriorating retaining wall

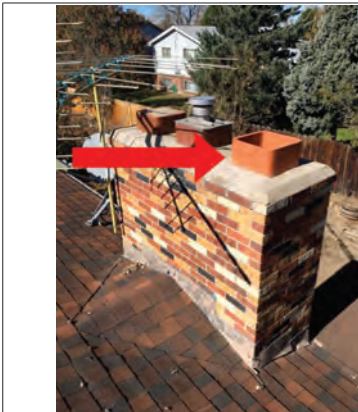
Chimney chase. Note missing rain cap and spark arrestor

- Recommend a licensed contractor install a rain cap/spark arrestor on the chimney.
- The concrete chimney cap is cracked in several locations. Recommend a licensed professional evaluate and seal the cracks/replace the cap as needed.

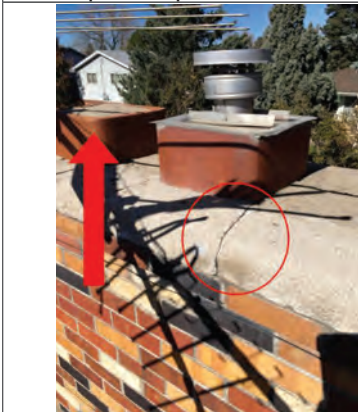
The concrete chimney cap is cracked in several locations. Recommend a licensed professional evaluate and seal the cracks/replace the cap as needed.
 Chimney has one flue liner that appears to be sealed by concrete. See photo.

Chimney cap has cracks. Note concrete sealed flue liner

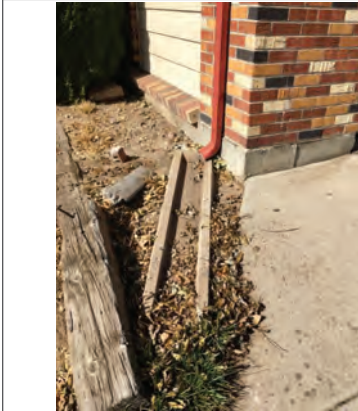
Splash block may not channel water effectively

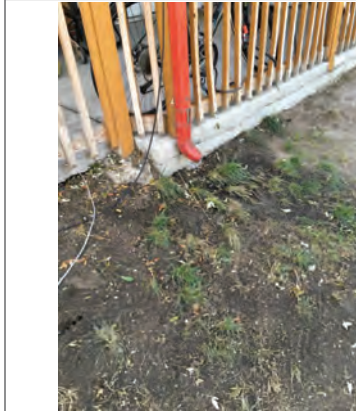
Missing downspout extension

- Recommend adding downspout extensions to discharge water away from the house. 5-6' extensions recommended.
- The gutters are dirty. Recommend cleaning the gutters to ensure proper water flow to the downspouts.

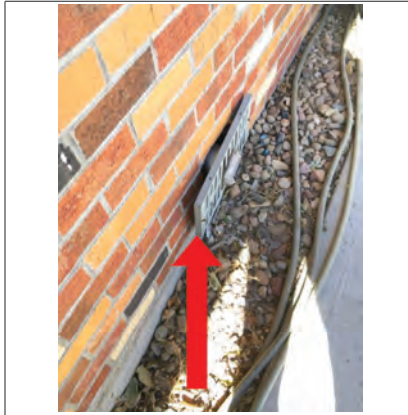
Comments Crawlspace vent is loose on east exterior wall. In current condition could allow rodents or insects to enter the home. See photo. Secure as needed.

Loose crawlspace vent

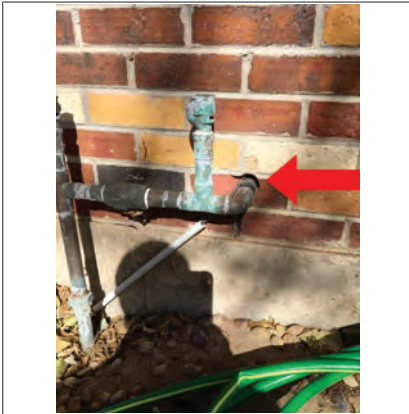
☐ None
Condition ☐ Satisfactory ☒ Marginal ☐ Poor
☒ Recommend around windows/doors/masonry ledges/corners/utility penetrations
Comments Recommend caulking around windows, doors, corners, utility penetrations to maintain weather seal.

Caulk as needed around wall penetrations

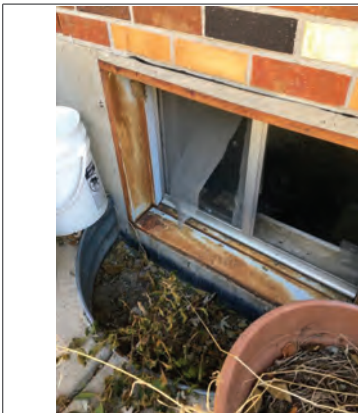
Damaged basement screen window

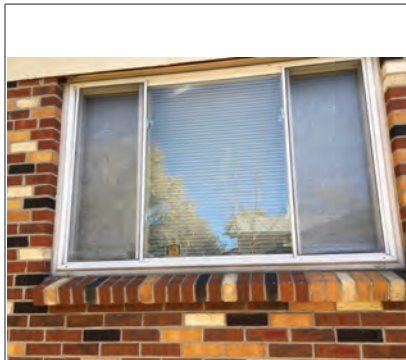
Deteriorating window screens

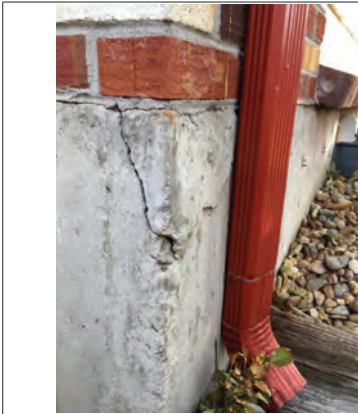
Foundation Wall ☐ Concrete block ☒ Poured concrete ☐ Post-Tensioned concrete ☐ Not Visible Other: .
Condition ☒ Satisfactory ☐ Marginal ☐ Monitor ☐ Have Evaluated ☐ Not Evaluated
Concrete Slab ☒ N/A ☐ Not Visible ☐ Satisfactory ☐ Marginal ☐ Monitor ☐ Have Evaluated
Comments Cracks were observed at foundation wall corners. Recommend monitoring these cracks and repairing if cracks worsen.

Corner crack

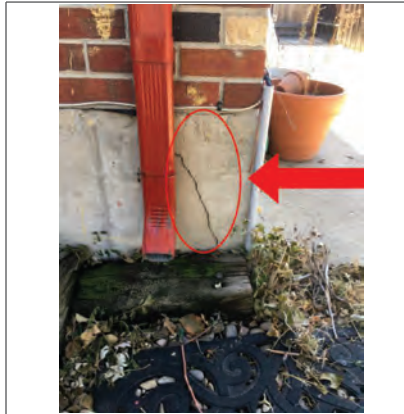
Larger corner crack

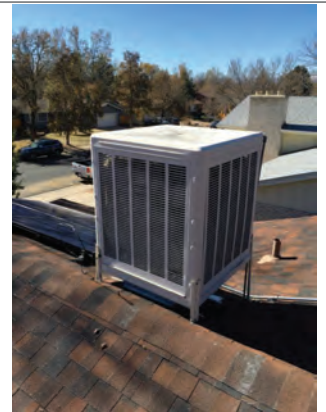
- Recommend removing abandoned roof top evaporative cooler and sealing roof as required. Flashing may be leaking as observed inside attic. At time of inspection unit motor was running and drive belt was broken. See photos.

Abandoned evaporative cooler.
 Belt is broken and needs serviced.

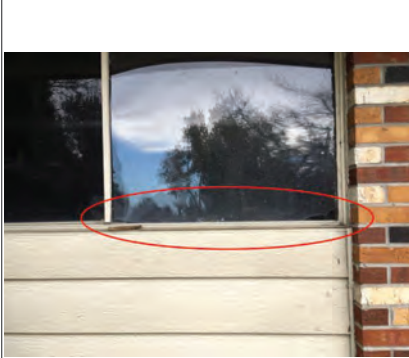
Comments Window pane is broken on garage window. Repair/Replace window as needed.

Broken window

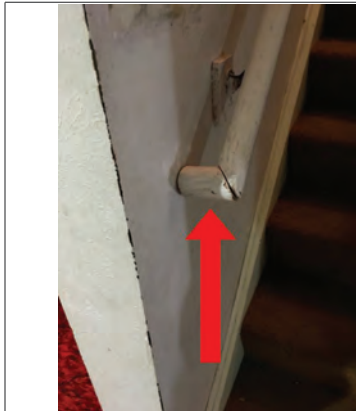
- The basement handrail is loose at the top of the stairs and has a loose return on the bottom. This is a potential safety concern. Recommend repair.

Loose return on handrail

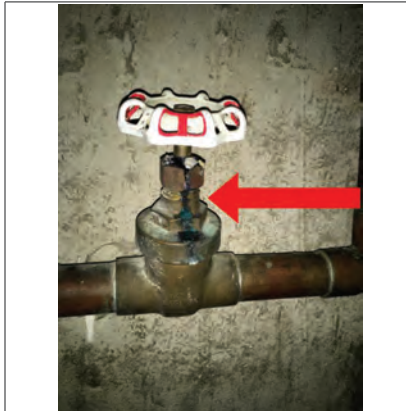
Comments Water supply pipes are leaking at the valve(s) - Recommend licensed plumber repair and/or replace.

Leaking valve

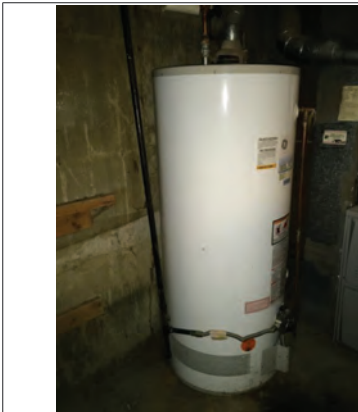
Water heater

Comments The average life expectancy for a gas fired water heater is 8-12 years. Recommend budgeting for replacement.
 There are corroded pipes at the water heater. Recommend a licensed plumber repair.
 Flue pipe draft hood is not secured to top of water heater and could be bumped out of position. This is a potential safety concern. Recommend securing as required.

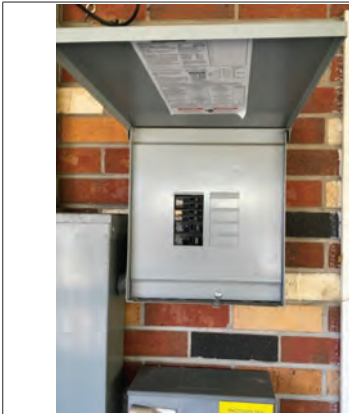
Sub panel

- Basement sub panel. Breakers have mechanical locks in place to keep them from tripping. Unsure if this is a safety concern or if licensed electrician installed them and breaker in main panel is responsible for wire protection. Recommend electrical inquiry be made.

☐ None apparent
Location(s) Location 1: Exterior wall
 Location 2: Basement
Evaluation ☐ Panel not accessible ☐ Not evaluated
 Reason:
☐ Recommend separating/isolating neutrals ☐ Recommend electrician repair/evaluate box
☒ No Deficiencies Observed
Branch wire ☒ Copper ☐ Aluminum ☐ Safety hazard Neutral/ground separated: ☒ Yes ☐ No Neutral isolated:
☒ Yes ☐ No
Condition ☒ Satisfactory ☐ Marginal ☐ Poor
Comments Circuits not labeled on exterior sub panel. Recommend labeling as required.
 Basement sub panel. Breakers have mechanical locks in place to keep them from tripping. Unsure if this is a safety concern or if licensed electrician installed them and breaker in main panel is responsible for wire protection. Recommend electrical inquiry be made.

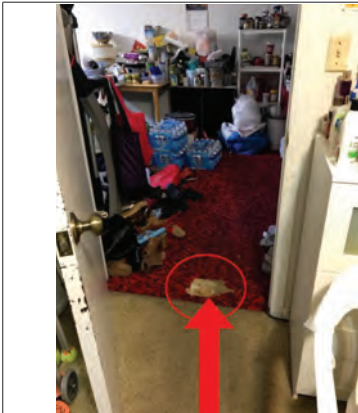
Family room as seen from bedroom
Carpet has tripping hazard.

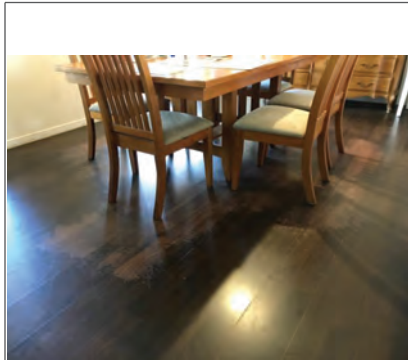
Wood floor finish is showing signs of wear. Refinish to protect wood.

Floor is worn

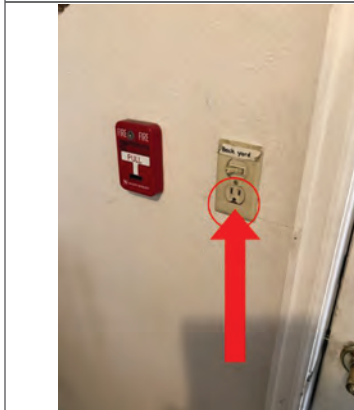
Dining room
Damaged receptacle

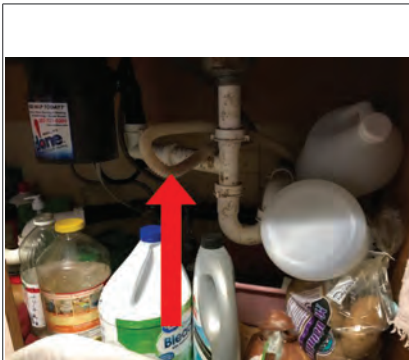
Comments Dishwasher drain line is not high looped beneath countertop. This could allow cross contamination between the sink and the dishwasher. Recommend installing a drain high loop.

Plumbing under kitchen sink
No high loop

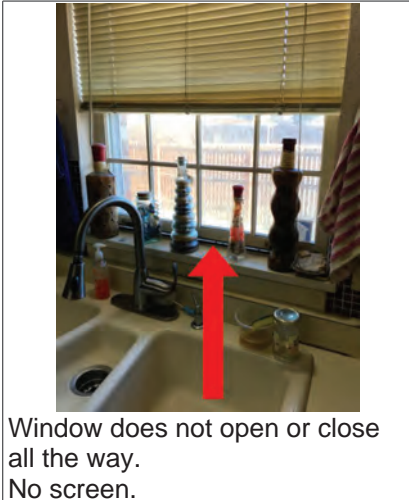
There is a window in the kitchen that will not open and does not close completely. Recommend a licensed contractor repair or replace as needed.

Window does not open or close all the way.
No screen.

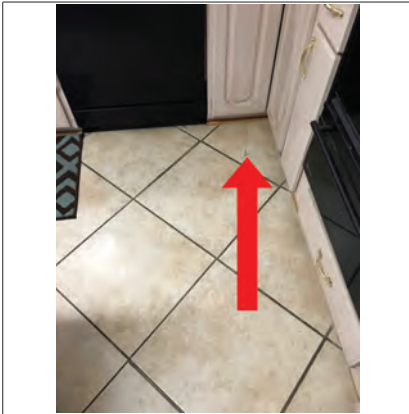
There is at least one cracked tile on the kitchen floor. Replace as needed.

Kitchen floor
Cracked tile

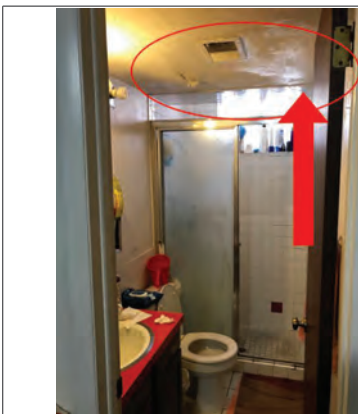
Ceiling has moisture damage evidenced by staining and peeling paint. Repair.

Bathroom 3 in basement
Water damage on ceiling
evidenced by peeling paint

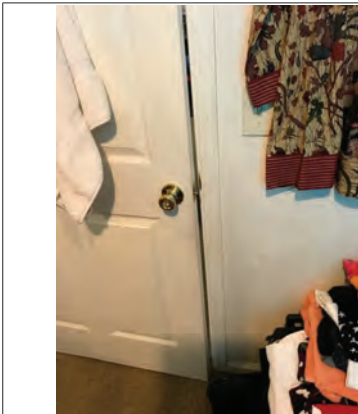
Door sticks

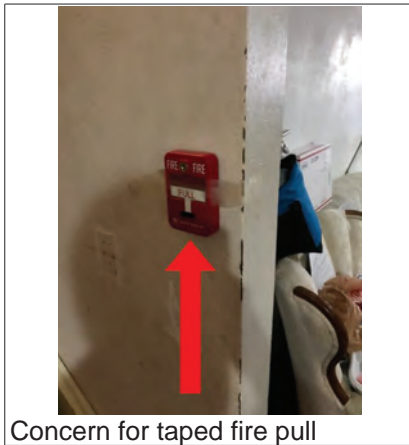
Note, one fire alarm pull was taped closed. (bottom of stairs). Recommend having inspected for operation.

Concern for taped fire pull
