## HOME INSPECTION

08/04/17

5840 Pocahontas Trail  
Providence Forge, VA 23140

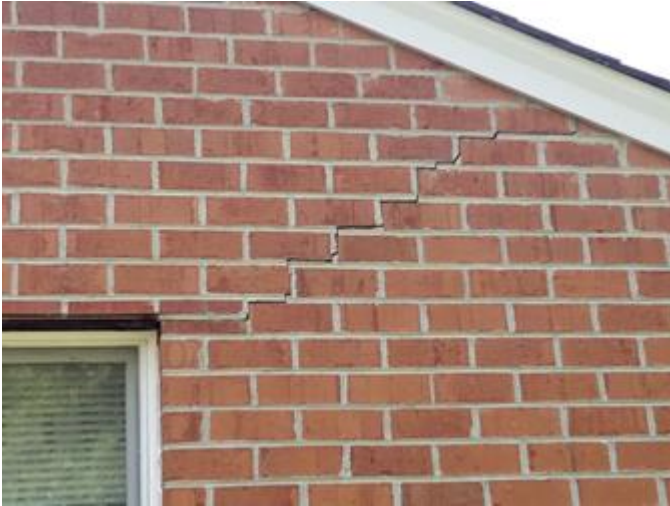
- 01 There are cracks in the masonry wall at a lintel. This implies that the lintel has begun to rust and expand, putting enough pressure on the surrounding masonry to crack it. Location: Left side. *Hire a contractor to make required repairs.*  
Estimated cost: \$160 - \$240

- ❌ Issue There are cracks in the masonry wall at a lintel. This implies that the lintel has begun to rust and expand, putting enough pressure on the surrounding masonry to crack it.
- Location Left side
- Action *Hire a contractor to make required repairs.*
- Cost \$160 - \$240

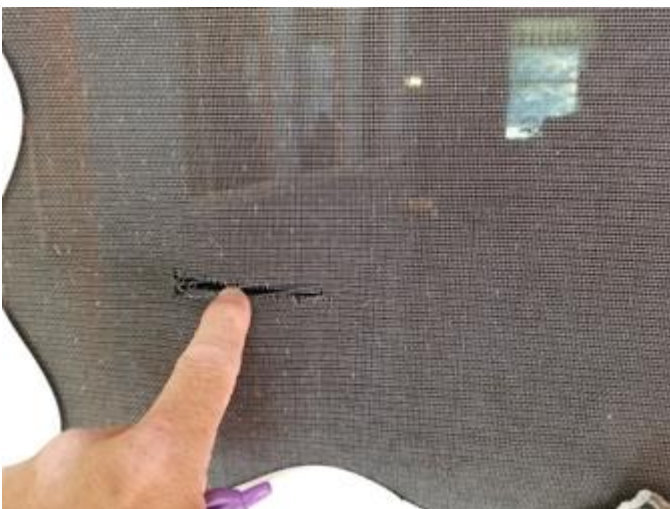
- 02 The screen is ripped at the door. Location: Rear. *Have the screen repaired* Estimated cost: \$80 - \$120

- ❌ Issue The screen is ripped at the door.
- Location Rear
- Action *Have the screen repaired*
- Cost \$80 - \$120

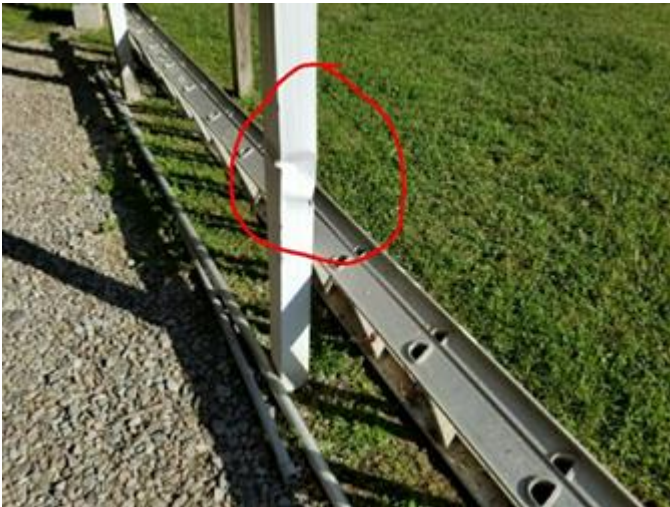
- 03 There are damaged supports at the carport. This is a safety hazard. *Repair or replace the supports.* Estimated cost: \$320 - \$480

✗ Issue There are damaged supports at the carport. This is a safety hazard.  
Location  
Action *Repair or replace the supports.*  
Cost \$320 - \$480

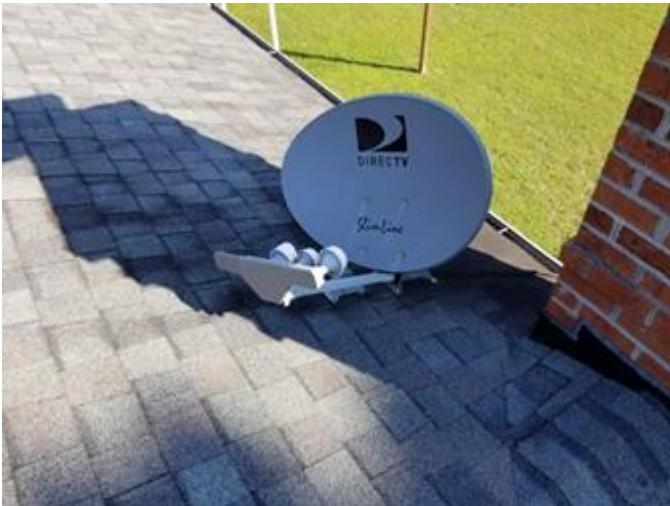
- 04 There is a satellite dish or TV antenna attached directly to the roof covering. This can damage the roofing and permit water penetration. Location: Rear. *Hire a contractor to make required repairs.* Estimated cost: \$120 - \$180

- ✕ Issue There is a satellite dish or TV antenna attached directly to the roof covering. This can damage the roofing and permit water penetration.
- Location Rear
- Action *Hire a contractor to make required repairs.*
- Cost \$120 - \$180

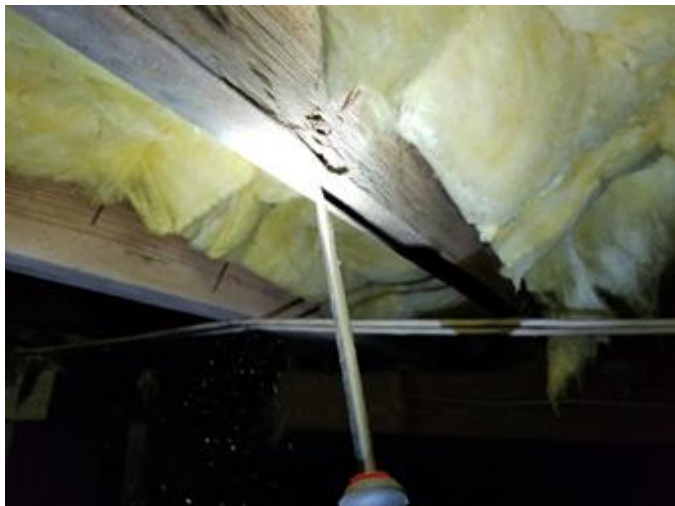
- 05 The joist is deteriorated. This can affect its load-bearing capacity. The cause of the deterioration should be identified. Location: Crawl rear middle. *Hire a contractor to make required repairs.* Estimated cost: \$180 - \$270

- ❌ Issue The joist is deteriorated. This can affect its load-bearing capacity. The cause of the deterioration should be identified.
- Location Crawl rear middle
- Action *Hire a contractor to make required repairs.*
- Cost \$180 - \$270

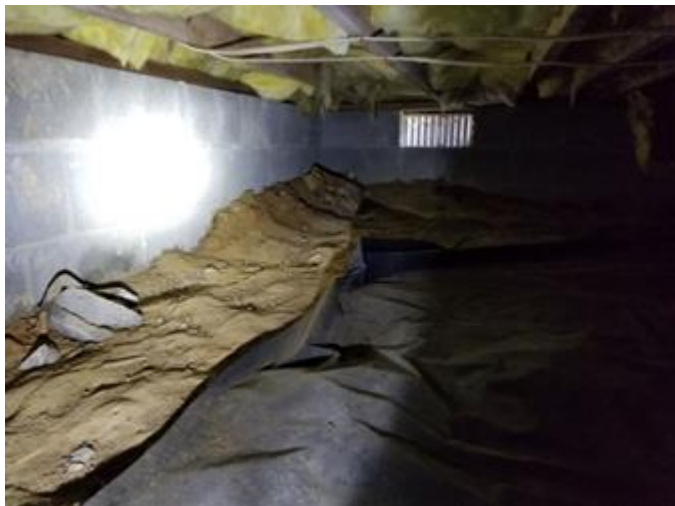
- 06 The crawl space vapor retarder does not cover all areas. This will raise the humidity and is conducive to moisture related problems. Location: Crawl space. *Hire a contractor to make required repairs.* Estimated cost: \$120 - \$180

- ❌ Issue The crawl space vapor retarder does not cover all areas. This will raise the humidity and is conducive to moisture related problems.
- Location Crawl space
- Action *Hire a contractor to make required repairs.*
- Cost \$120 - \$180

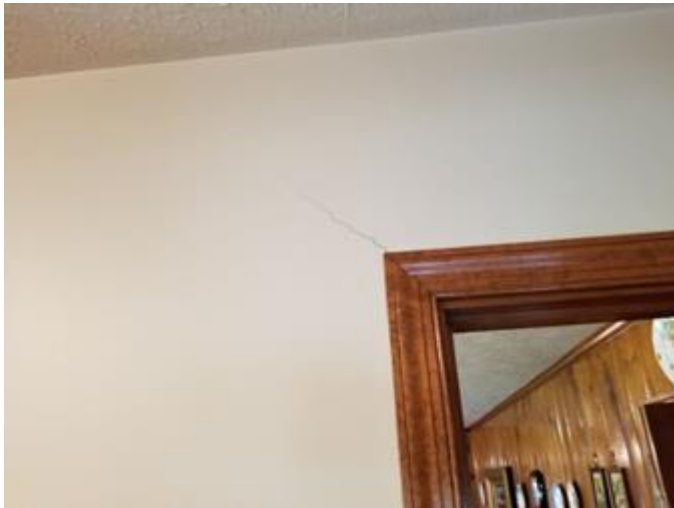
- 07 There is minor crack into the interior wall. This indicates minor settlement Location: Laundry room. *Repair the wall as necessary* Estimated cost: \$120 - \$180

✗ Issue	There is minor crack into the interior wall. This indicates minor settlement.
Location	Laundry room
Action	<i>Repair the wall as necessary</i>
Cost	\$120 - \$180

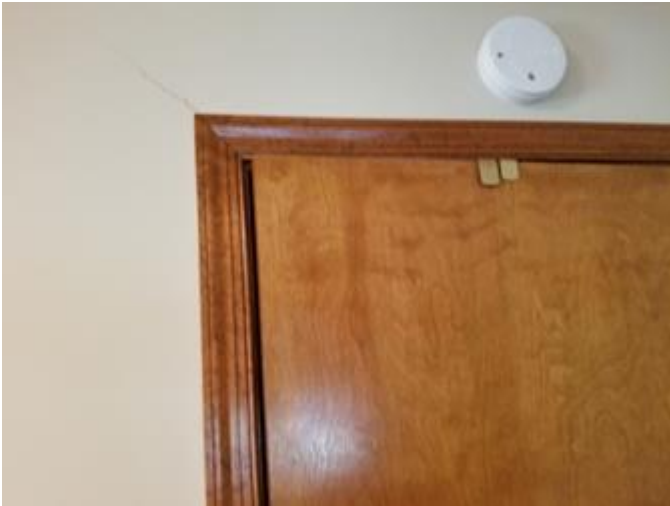
- 08 The door does not fit and seal properly within frame. Location: Laundry room, front right bedroom. *Hire a contractor to make required repairs.* Estimated cost: \$100 - \$150

✗ Issue The door does not fit and seal properly within frame.  
Location Laundry room, front right bedroom  
Action *Hire a contractor to make required repairs.*  
Cost \$100 - \$150

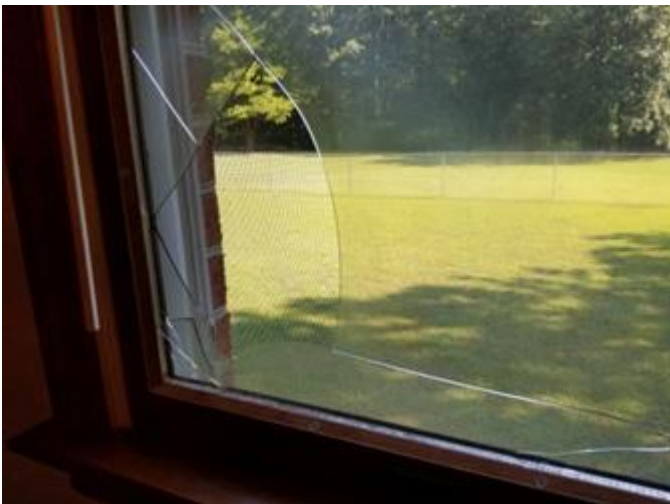
- 09 The window pane is broken. This is an energy loss and safety issue. Location: Master bathroom. *Repair or replace the window.* Estimated cost: \$200 - \$300

✗ Issue The window pane is broken. This is an energy loss and safety issue.  
Location Master bathroom  
Action *Repair or replace the window.*  
Cost \$200 - \$300

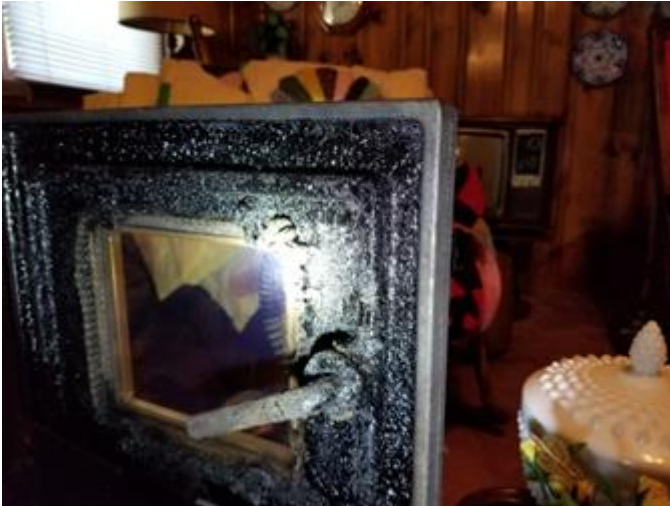
- 10 There is creosote build-up in the firebox. This is a safety issue. *Have a licensed chimney contractor clean and inspect the fireplace/chimney* Estimated cost: \$160 - \$240

- ✕ **Issue**      There is creosote build-up in the firebox. This is a safety issue.
- Location**
- Action**     *Have a licensed chimney contractor clean and inspect the fireplace/chimney*
- Cost**        \$160 - \$240

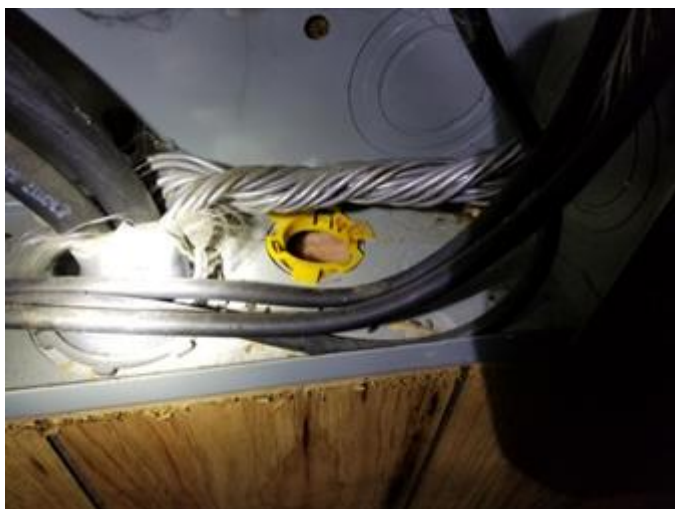
- 11 There are missing knockout covers at the electrical panel. This defeats the panel's fire rating, and permits accidental contact with energized components. *Hire an electrician to make required repairs.* Estimated cost: \$100 - \$150

✗ Issue There are missing knockout covers at the electrical panel. This defeats the panel's fire rating, and permits accidental contact with energized components.

Action *Hire an electrician to make required repairs.*

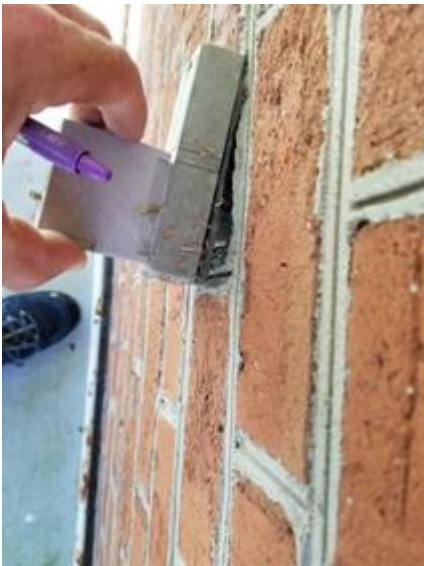
✗ **Issue** The outlet box is loose. This is a safety concern.  
**Location** Rear left of house at exterior  
**Action** Hire an electrician to make required repairs.  
**Cost** \$100 - \$150

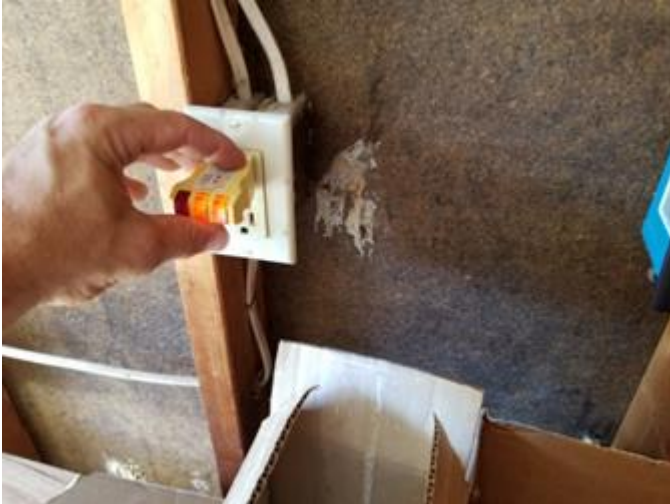
- ❌ **Issue** There is an inoperative GFCI receptacle. The receptacle has power, but it doesn't trip when the test button is pushed. This is a safety hazard.
- Location** Garage
- Action** *Hire an electrician to make required repairs.*
- Cost** \$100 - \$150

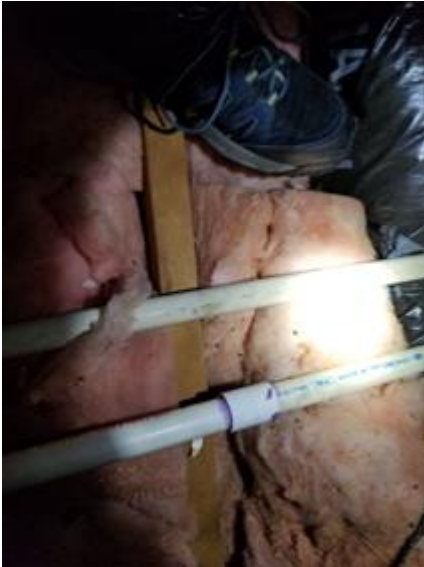
- 14 There is "sweating" noted on the outside of the condensate lines in the attic. This may be due to the warm humid air condensing on the cool lines. This may be causing the staining in the hallway below Location: Attic. *Hire an HVAC contractor to make required repairs.* Estimated cost: \$100 - \$150

- ⊗ Issue There is "sweating" noted on the outside of the condensate lines in the attic. This may be due to the warm humid air condensing on the cool lines. This may be causing the staining in the hallway below.
- Location Attic
- Action *Hire an HVAC contractor to make required repairs.*
- Cost \$100 - \$150

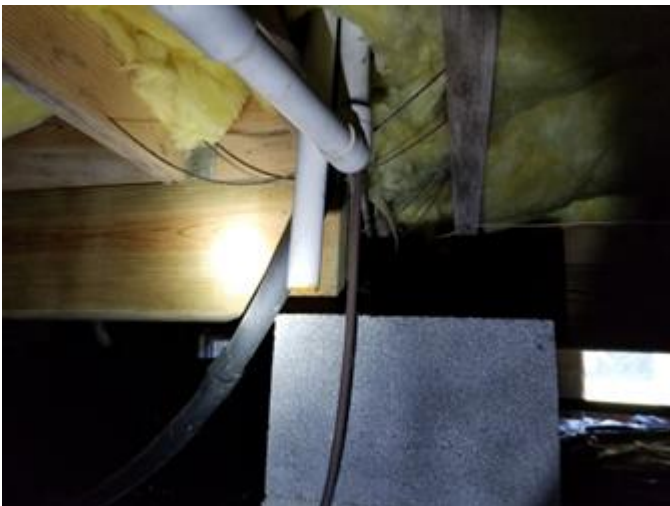
- 15 The condensate system's discharge point is improperly located. The condensate should be carried to the exterior and away from the building to prevent water damage and mold or mildew problems. Location: Crawl space. *Hire an HVAC contractor to make required repairs.* Estimated cost: \$140 - \$210

- ⊗ Issue The condensate system's discharge point is improperly located. The condensate should be carried to the exterior and away from the building to prevent water damage and mold or mildew problems.
- Location Crawl space
- Action *Hire an HVAC contractor to make required repairs.*
- Cost \$140 - \$210

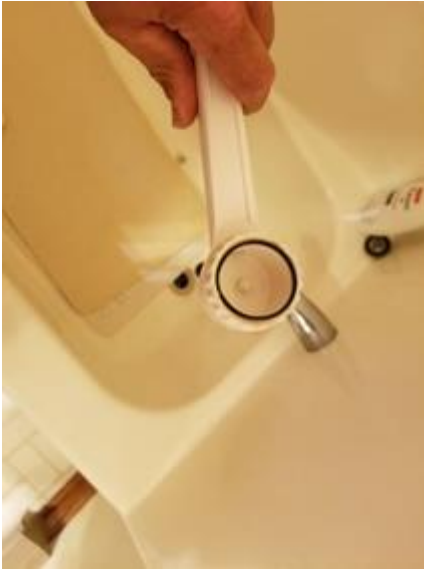
- 16 The shower head is broken. Location: Hall bath. *Hire a plumber to make required repairs.* Estimated cost: \$100 - \$150

- X Issue The shower head is broken.
- Location Hall bath
- Action Hire a plumber to make required repairs.
- Cost \$100 - \$150

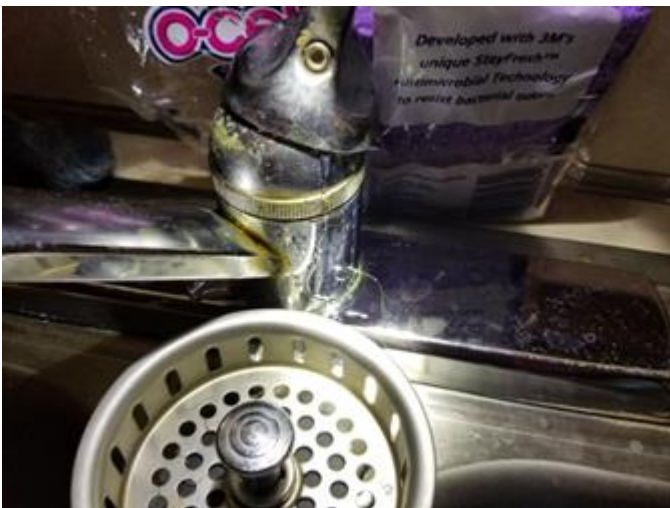
- 17 The sink faucet is leaking. This can allow water damage. Location: Kitchen. *Hire a plumber to make required repairs.* Estimated cost: \$140 - \$210

- X Issue The sink faucet is leaking. This can allow water damage.
- Location Kitchen
- Action Hire a plumber to make required repairs.
- Cost \$140 - \$210

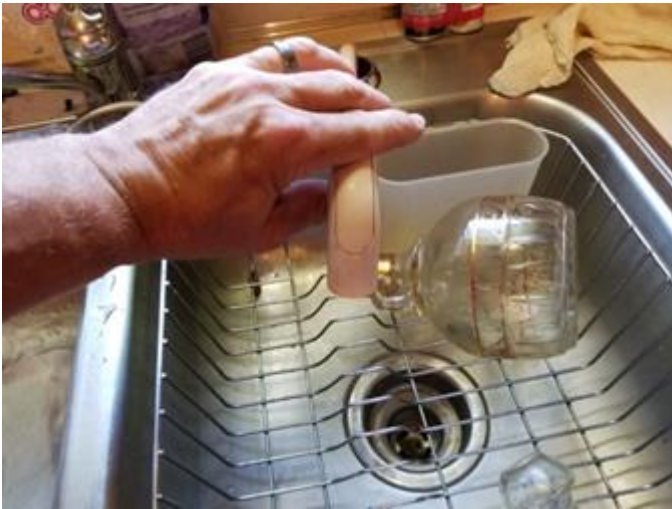
- 18 The spray wand is inoperable. Location: Kitchen. *Hire a plumber to make required repairs.* Estimated cost: \$100 - \$150

- ✕ Issue     The spray wand is inoperable.
- Location   Kitchen
- Action     *Hire a plumber to make required repairs.*
- Cost        \$100 - \$150

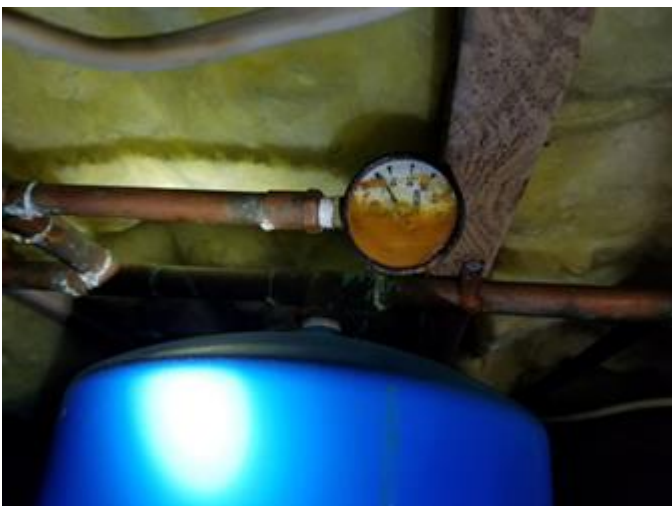
- 19 The well pressure guage is broken or the bladder is damaged. Location: Crawlspace. *Hire a plumber to make required repairs.*

- ✕ Issue     The well pressure guage is broken or the bladder is damaged.
- Location   Crawlspace
- Action     *Hire a plumber to make required repairs.*

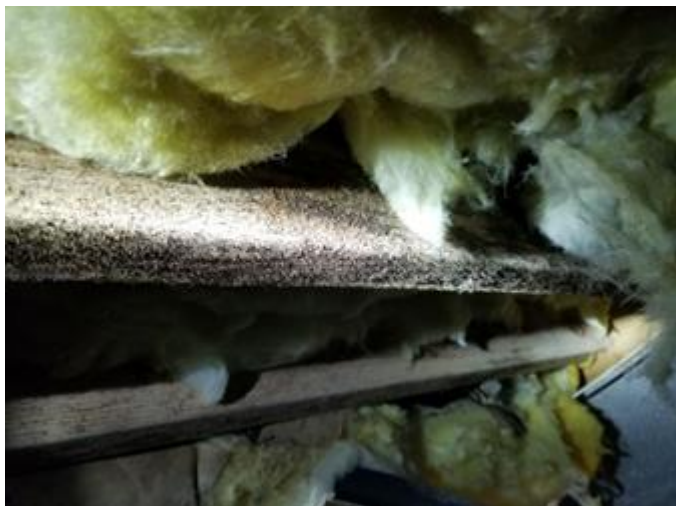
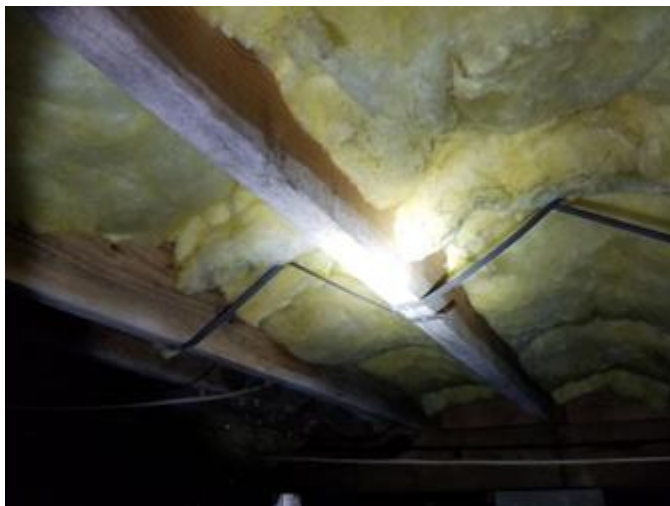
- 20 There is suspected mold/fungus build-up. Mold/fungus growth can lead to deterioration of structural members and may present health problems. Hire an environmental specialist for further evaluation and repairs. Location: Crawlspace.

There is suspected mold/fungus build-up. Mold/fungus growth can lead to deterioration of structural members and may present health problems. Hire an environmental specialist for further evaluation and repairs.
