Phase 1 Environmental Site Assessment for River's Edge Apartments 4400 Dixie Highway NE, Palm Bay, FL 32905

WGI Project No. 14228452.00 Report Issuance Date: July 26, 2022 Report Expiration Date: January 8, 2023

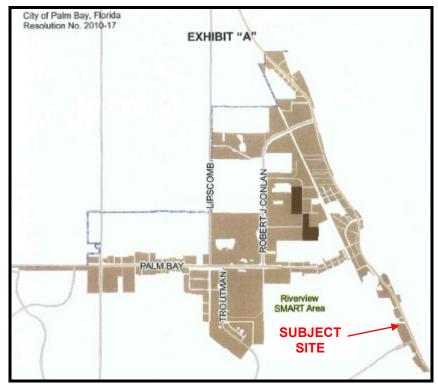
City of Palm Bay Designated Riverview S.M.A.R.T. Brownfield Area

Riverview S.M.A.R.T., Palm Bay: In May 2010, the City of Palm Bay designated the "Riverview Sustainable Market and Reinvestment Target" (Riverview S.M.A.R.T.) a Brownfield area so all property within with actual or perceived environmental contamination would be eligible for environmental remediation and economic development incentives under Florida's Brownfields Redevelopment Act. Though the Subject Property is located within the Reinvestment Target (S.M.A.R.T.) area, as of the date of this report it is not a designated Brownfield site with a FDEP-approved Brownfield Site Rehabilitation Agreement (BSRA). WGI does not consider the mere presence of the Subject Property within the Riverview S.M.A.R.T. to constitute a REC. Exhibit "A," below, depicts the designated brownfield area.

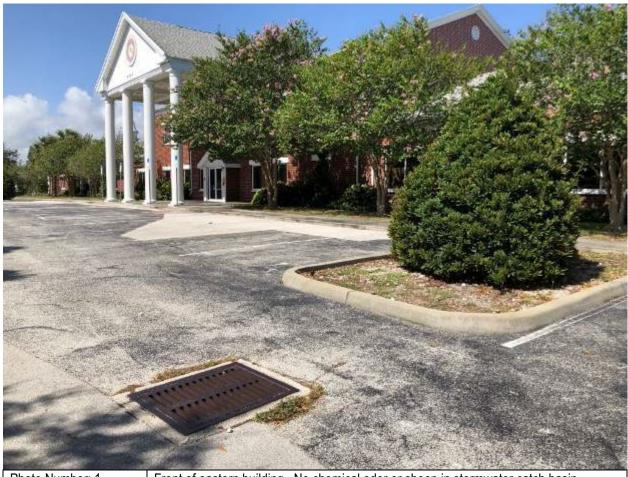
Photo date: 7/15/2022 Direction: SW

Front of eastern building. No chemical odor or sheen in stormwater catch basin.

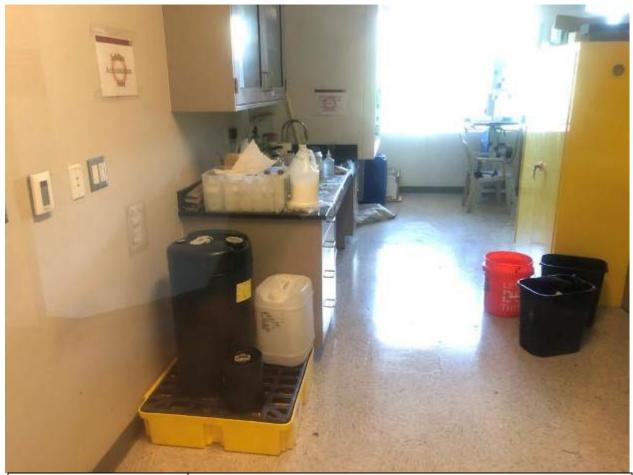
Photo date: 7/15/2022

Eastern building. Polymer science laboratory. Chemicals on secondary containment. Flammables cabinet at right.

- WGI observed a yellow metal cabinet for flammables in one of the laboratory rooms. The laboratory rooms
 have exhaust hoods and there are several exhaust vents that protrude high above the roof.

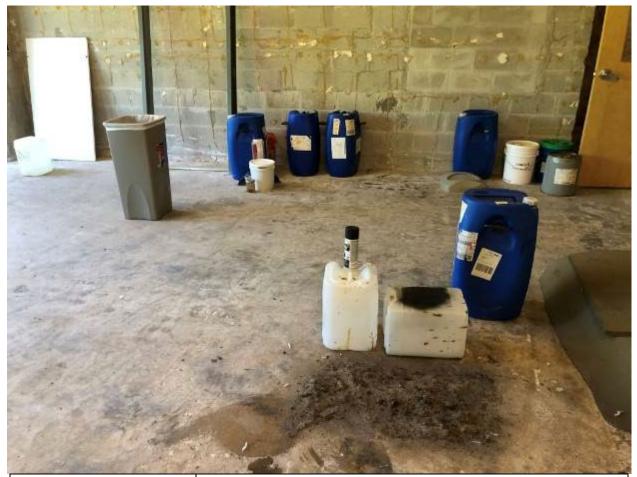
Photo Numbers: 4
Photo date: 7/15/2022

Eastern building. Next to the polymer science laboratory. Several plastic containers – some are labeled "aerogel particles." No staining of the concrete floor. This is one of several rooms with floor drains.

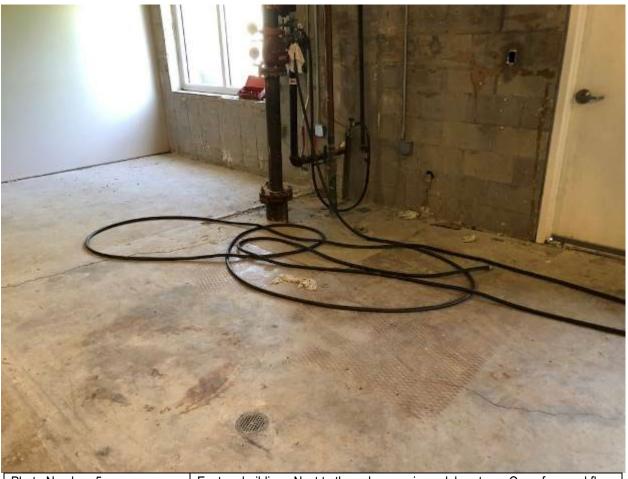
Photo Number: 5 Photo date: 7/15/2022

Eastern building. Next to the polymer science laboratory. One of several floor drains.

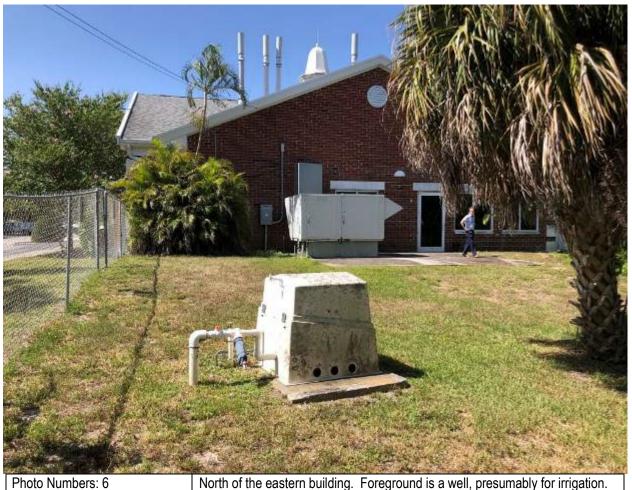
Photo date: 7/15/2022 Direction: S North of the eastern building. Foreground is a well, presumably for irrigation. Several vent pipes are evident in the roof of the eastern building – these are apparently for the exhaust hoods in the laboratory rooms.

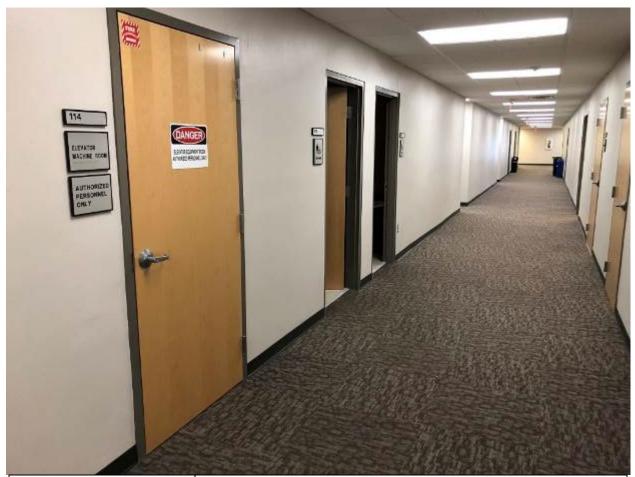
Photo date: 7/15/2022

Eastern building, second floor. Office space with elevator machine room.

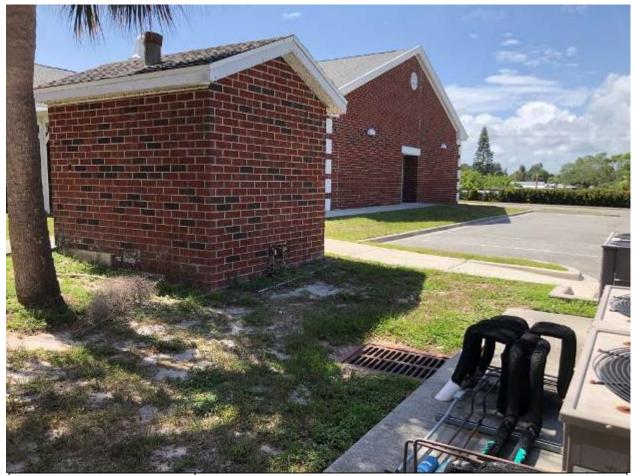
Photo Number: 8 Photo date: 7/15/2022

Brick shed with vent in roof and natural gas lines. No evidence of an AST or UST.

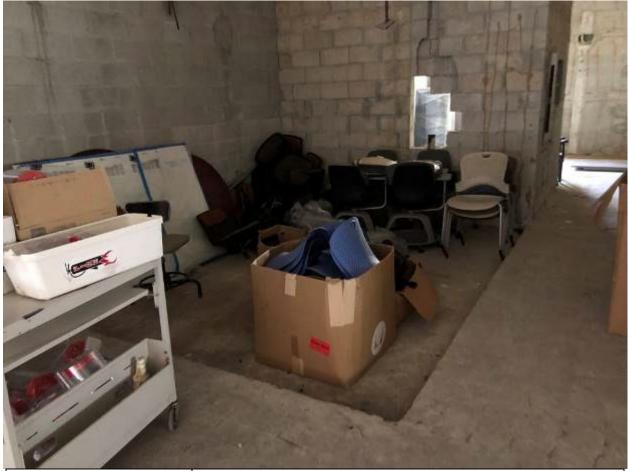
Photo date: 7/15/2022

Western building, interior. Unfinished and used for storage of office furniture and similar materials.

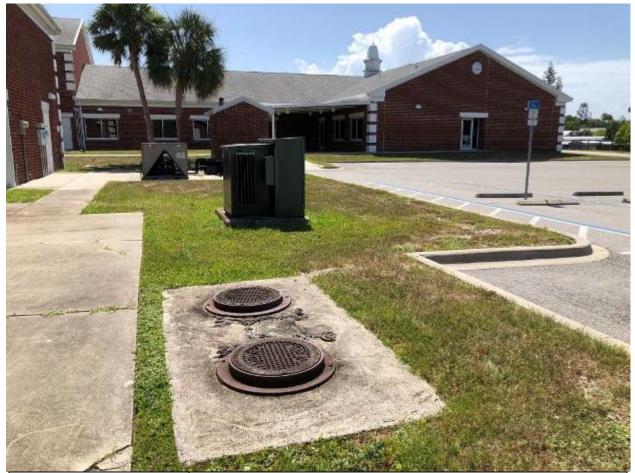
Photo Number: 11
Photo date: 7/15/2022

Manholes for sanitary sewer (grease trap). Pad-mounted electrical transformers. HVAC equipment. Brick shed with roof vent.

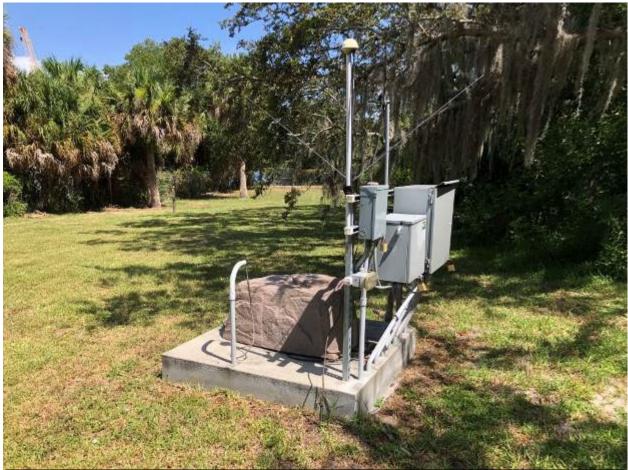
Photo date: 7/15/2022

Apparent seismometer.

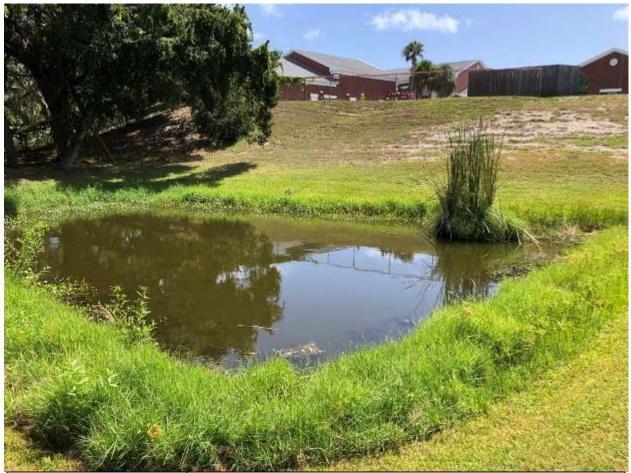
Photo date: 7/15/2022 Direction: NE Stormwater pond in southwest corner. No chemical odor, sheen, or stressed vegetation.
