Home Inspection Report

12099 E Louisiana Ave., Aurora, CO 80012

Saturday, October 26, 2019

Seamless Home Inspection, LLC

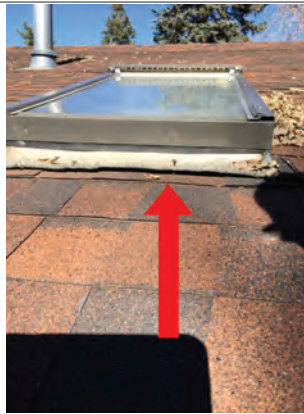
Skylight flashing is separated from roof

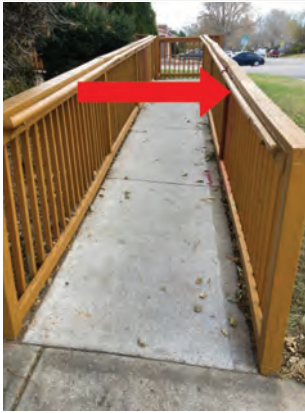
- Handrails are loose going up the service ramp to the front door and on the back of the home. This is a safety concern. Recommend repair.

Front service ramp. Handrail is loose

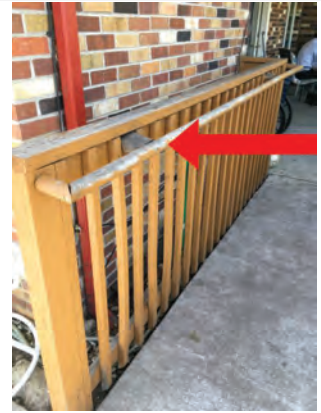
Handrail is loose

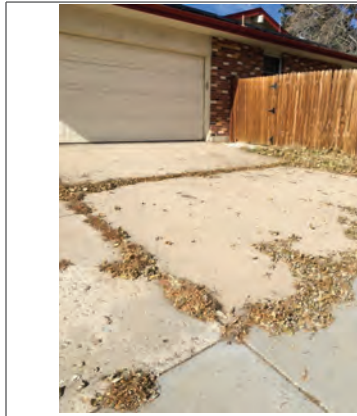
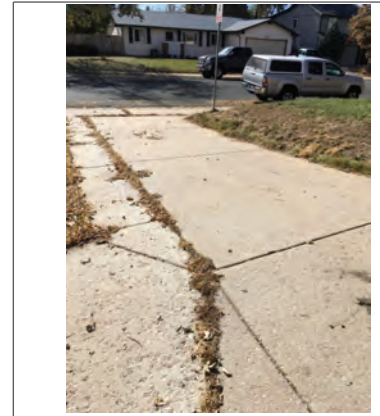
☐ None ☐ Not Visible
Material ☒ Concrete ☐ Asphalt ☐ Gravel/Dirt ☐ Brick Other: ☐ Metal
Condition ☒ Satisfactory ☐ Marginal ☐ Poor ☐ Settling Cracks ☒ Typical cracks ☐ Pitched towards home
☐ Trip hazard ☐ Fill cracks and seal
Comments The driveway has normal cracking. Recommend sealing the cracks with a product like Sikaflex to help prevent additional damage.
 The driveway has areas of spalling. Spalling can not be successfully patched. Monitor and replace the slab as needed.

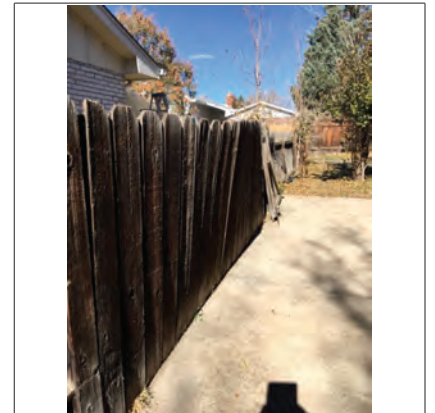
- East gate may be operational but has damaged hinges. Repair as needed. West gate was operational.
- Fencing was in need of maintenance repairs. Repair as needed.

Leaning fence on west side

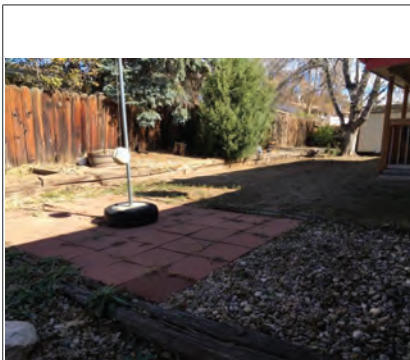
Rear retaining wall

The retaining wall(s) are made using wood timbers. The timbers are deteriorating. Recommended replacing rotten timbers and fortifying the wall as needed.

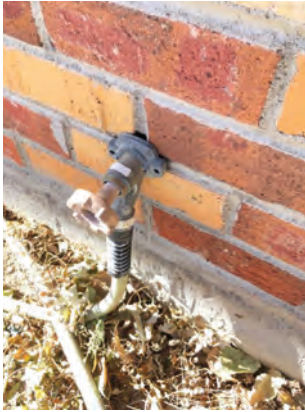
- The hose bibs are not secured to the house. This may cause damage over time. Recommend securing the hose bibs to the house.
- Recommend removing hoses from exterior faucets when freezing temperatures are expected. Frost proof hose bibs may

Hose bib not secure to home

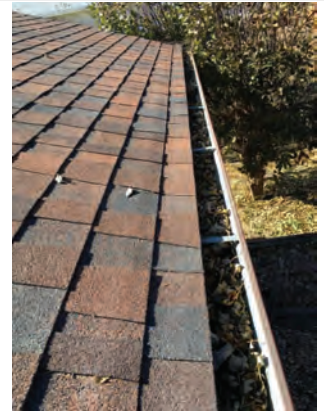
Dirty gutter on rear of home

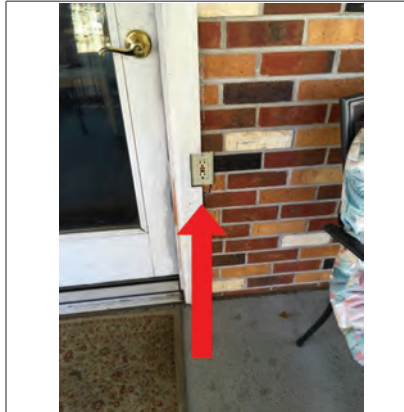
- The exterior GFCI receptacle on the patio would not trip when tested. This is a safety concern. Recommend a licensed electrician replace as needed.

Patio GFCI receptacle would not trip when tested

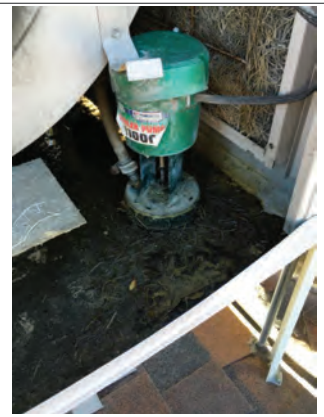
The air conditioner could not be operated because the overnight temperature was too low. Operating the air conditioner could damage the compressor when overnight lows are less than 60 degrees.
 Recommend removing abandoned roof top evaporative cooler and sealing roof as required. Flashing may be leaking as observed inside attic. At time of inspection unit motor was running and drive belt was broken. See photos.

Cooler not functional

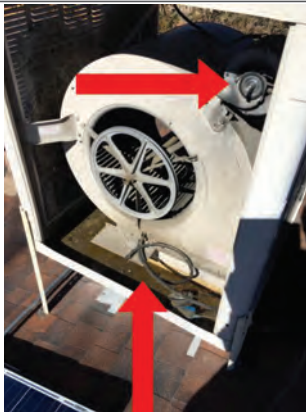
Broken belt and sheave has fallen off motor.

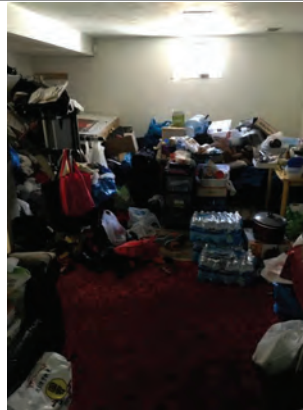
Basement floor is covered with flooring material and not visible. Inspection of concrete slab was limited.

Basement floor not visible

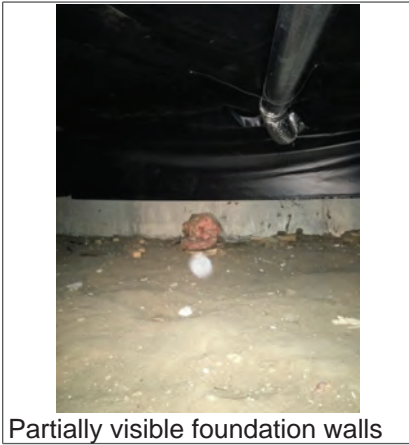
Walls were partially covered with vapor barrier. Inspection was limited.

Partially visible foundation walls

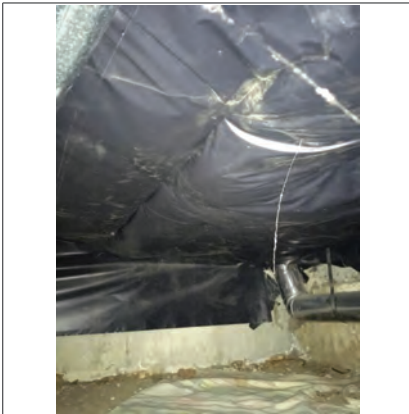
☐ N/A
Location ☒ Wall vents ☐ Power vents ☐ None apparent
Condition ☐ Additional ventilation recommended ☐ Evidence of moisture damage ☐ No Deficiencies Observed
☒ Wall Vents Blocked
Comments The wall vents around the crawlspace appear to be blocked by ceiling installed vapor barrier.

Vapor barrier installed over floor joists in crawlspace

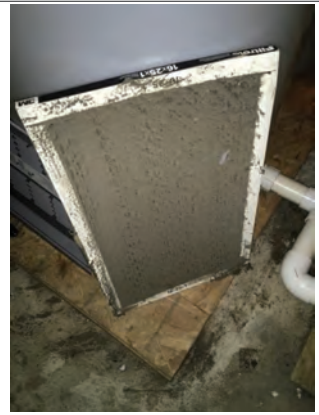
Severely dirt covered furnace filter. Filter was intentionally left out of furnace for obvious reasons.

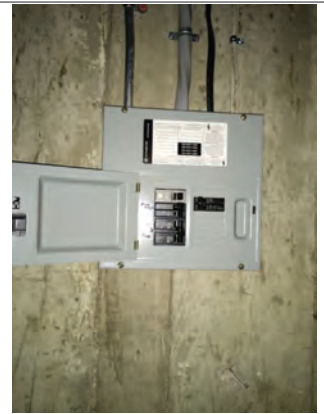
Basement sub panel. Breakers have mechanical locks in place to keep them from tripping. Unsure if this is a safety concern or if licensed electrician installed them and breaker in main panel is responsible for wire protection. Recommend electrical inquiry be made.

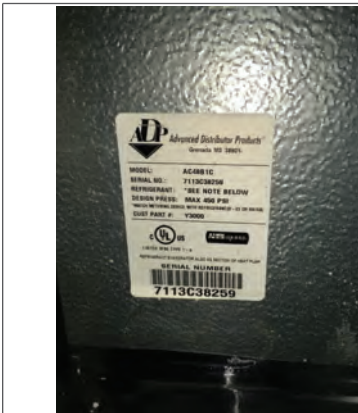
Air conditioning evaporator coil data plate

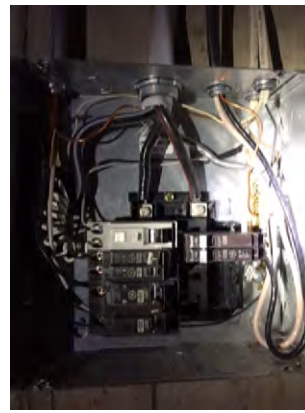
Basement sub panel. Cover removed for inspection.

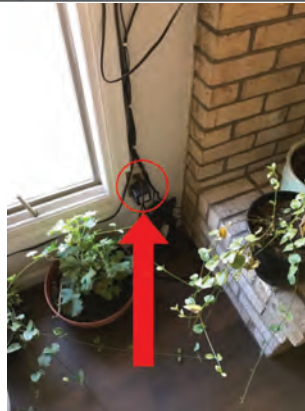
Unable to check receptacle due to equipment plugged in

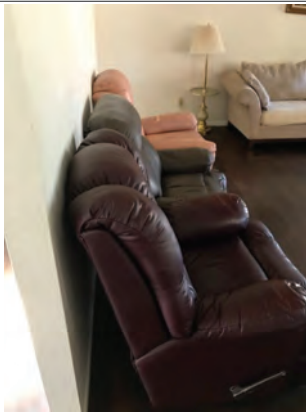
Furniture in way of receptacles

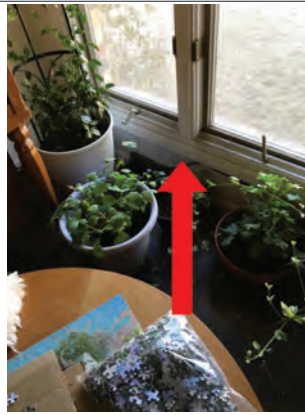
Unable to verify if windows are tempered

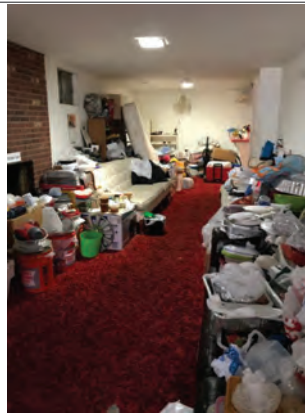
Family room
Limited inspection

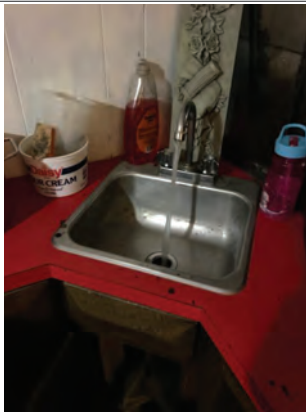
Only hot water is available at wet bar sink. Right handle or cold water does not turn.

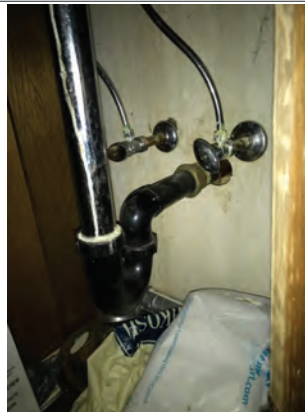
Corroded valves at sink

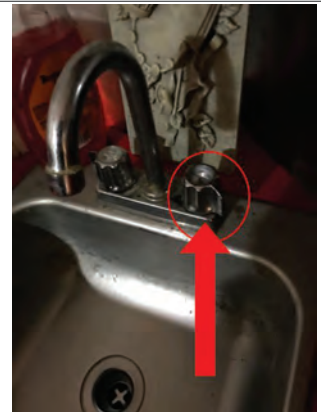
Handle does not turn

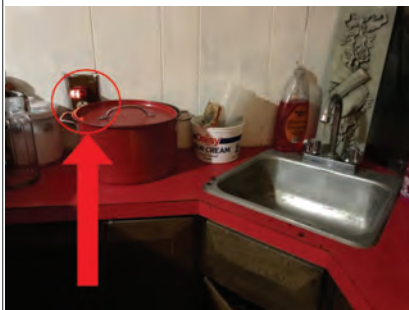
The wet bar is missing a GFCI. This is a safety concern. GFCI receptacles should be installed at all locations within six feet of water. Recommend a licensed electrician install GFCI receptacles.

No GFCI

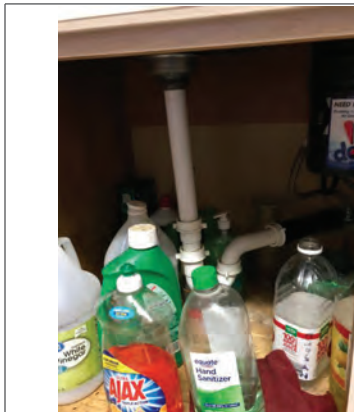
Comments Dishwasher drain line is not high looped beneath countertop. This could allow cross contamination between the sink and the dishwasher. Recommend installing a drain high loop.

Plumbing under sink

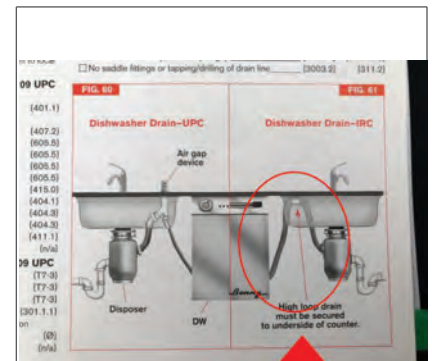
See above diagram for
dishwasher drain to be
highlooped

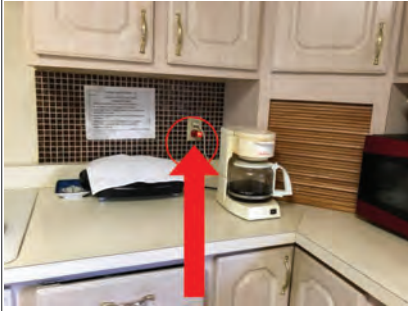
No GFCI

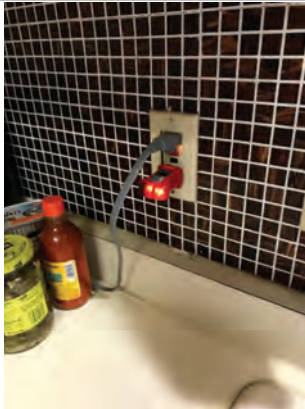
GFCI does not trip

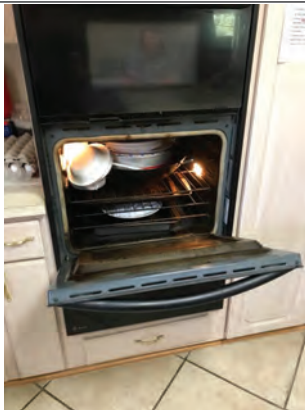
Wall oven used for storage

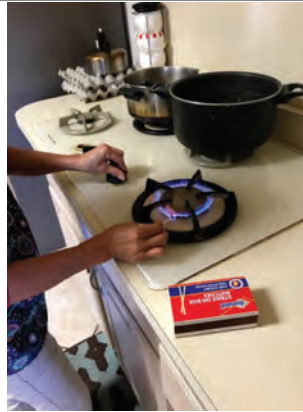
Countertop stove burners had to be lit with matches. This is a safety hazard. Should the burner be turned on accidentally and not lit with matches, gas would continue to flow and an explosion could happen. Recommend repair or replace unit.
 There is at least one receptacle within 6' of the sink not GFCI protected. This is a safety concern. Recommend a licensed electrician install GFCI receptacles where required.
 The GFCI left of sink does not trip when tested. This is a safety concern. Recommend a licensed electrician replace.

Required match light

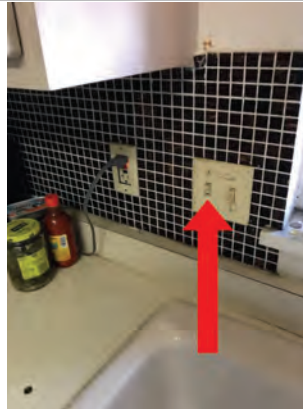
Unknown what left switch operates

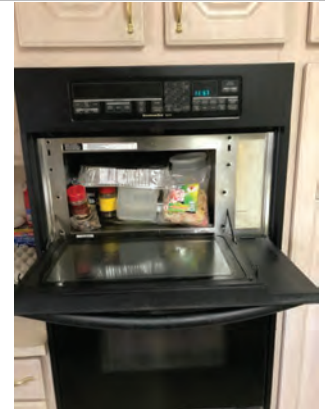
Wall microwave filled with supplies

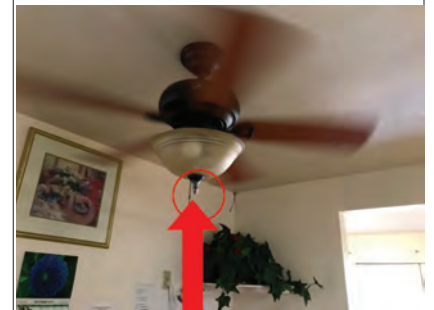
Screw does not hold globe in place, tape is being used
Fan speeds are not able to be changed

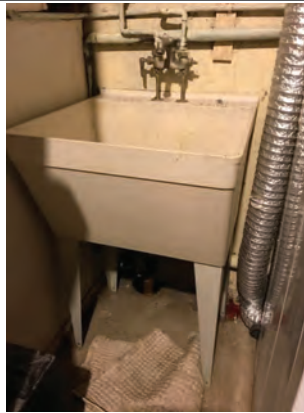
Inoperable laundry sink faucet
 Unable to determine usefulness.
 Not evaluated
 Faucet handle missing

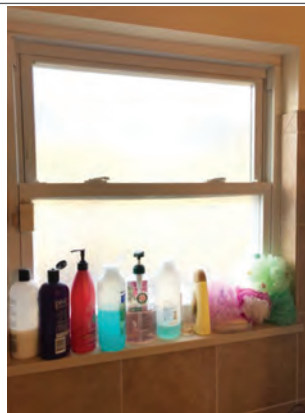
Unable to open window

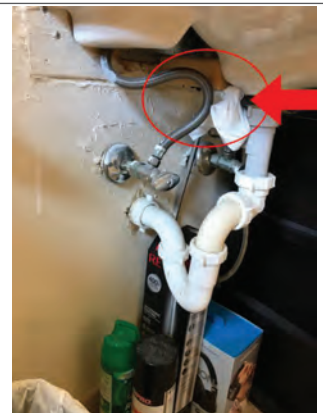
Questionable stability and leak free sink
There appears to be a board wedged for support of sink
Uncertain why paper towel is wedged in place.

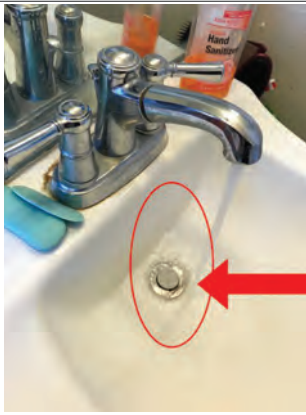
Sink stopper does not stay closed

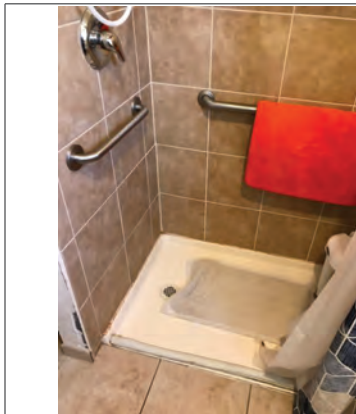
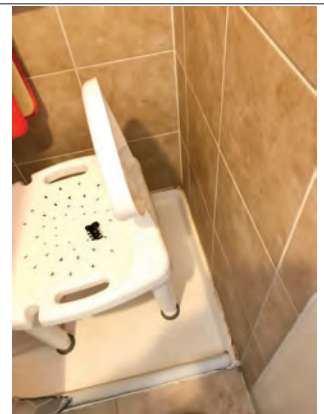
Caulking needed

Recommend caulking/grouting in shower/tub area to help prevent damage from water penetration.

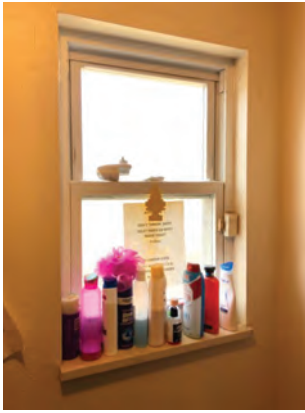
Unable to open windows in all bathrooms despite attempt and there is no exhaust fan leading to concerns of moisture build up which can cause deterioration of building materials and potential mold growth.

Window does not open or is very difficult

Recommend licensed contractor evaluate and repair.

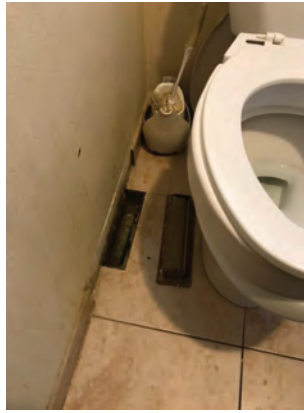
Heater vent is dislodged. Repair and secure.

Heater vent register loose

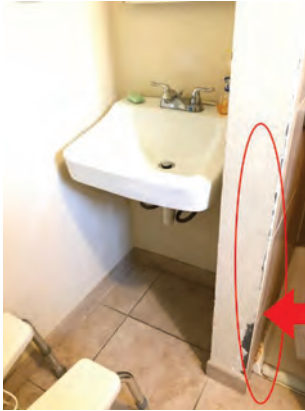
There is some wall damage. Repair.

Sink
Wall damage

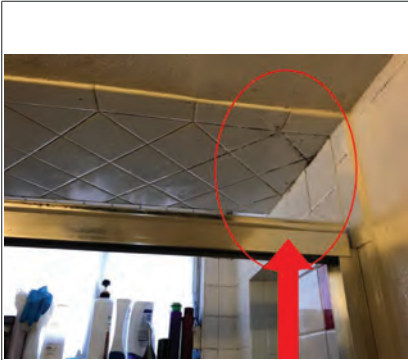
Mold like substance

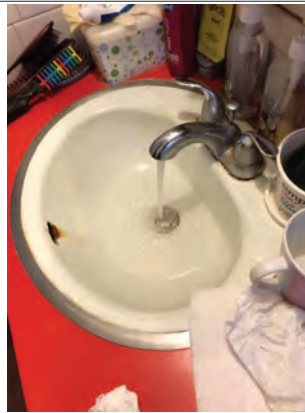
Rusted overflow

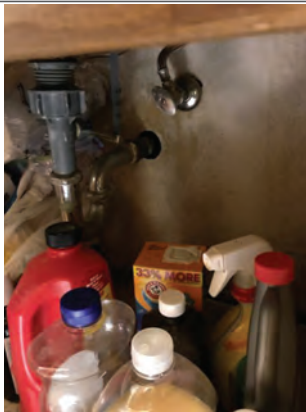
There is damage on the bathroom vanity. Repair or replace as needed.

Damaged cupboard/wall

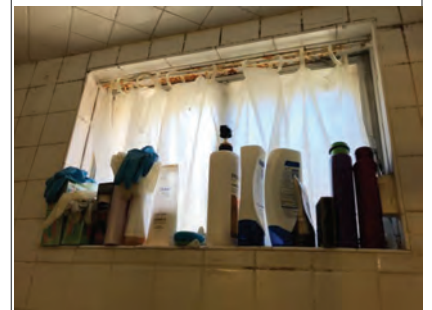
Could not check window

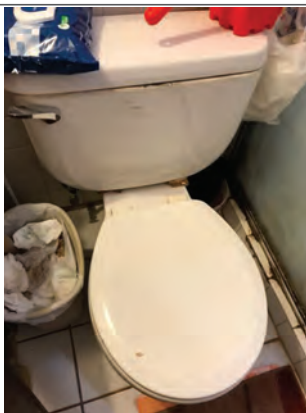
The toilet tank is loose and wedged in place with wood pieces, recommend replacing the wax ring. Repair or replace toilet.

Tank is wedged for support

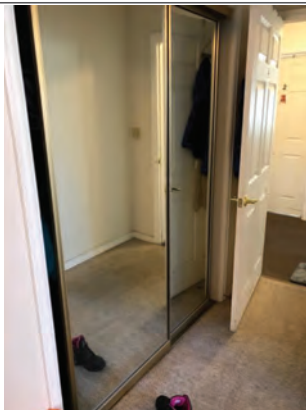
Glass mirror safety concern

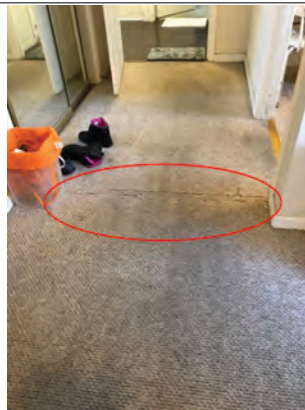
Comments The carpet is loose, torn and worn. This could be a potential trip hazard. Recommend replacing carpet.
The closet doors are solid mirrors and could be a potential safety concern in the event a person fell into them. Recommend replacing.

Carpet in poor condition

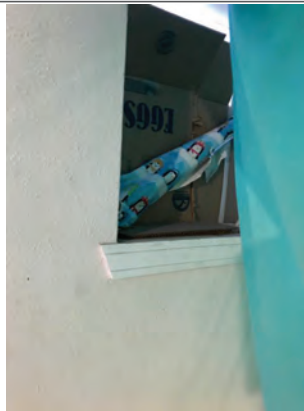
Small window blocked

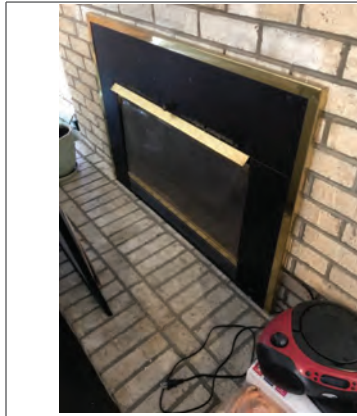
☐ None
Location(s) Living room
Type ☐ Gas ☐ Wood ☐ Solid fuel burning stove ☐ Electric ☐ Ventless
Material ☐ Masonry ☐ Metal (pre-fabricated) ☐ Metal insert ☐ Cast Iron
Miscellaneous ☐ Blower built-in Operable: ☐ Yes ☒ No Damper operable: ☐ Yes ☐ No
☐ Open joints or cracks in firebrick/panels should be sealed ☐ Fireplace doors need repair
Damper modified for gas operation ☐ N/A ☐ Yes ☐ No ☐ Damper missing
Hearth extension adequate ☒ Yes ☐ No
Mantel ☒ N/A ☐ Secure ☐ Loose ☐ Recommend repair/replace
Physical condition ☐ Satisfactory ☐ Marginal ☐ Poor ☐ Recommend having flue cleaned and re-examined
☐ Not evaluated
Comments This fireplace was totally sealed and unable to be inspected.
 Fireplace liner appeared to be sealed with concrete. See chimney section of report.

Fireplace in living room
Sealed

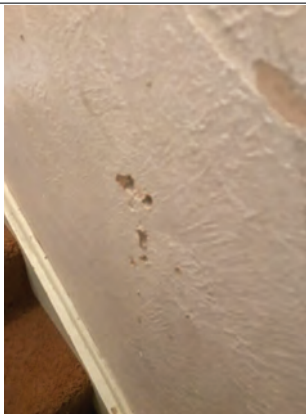
Wall damage

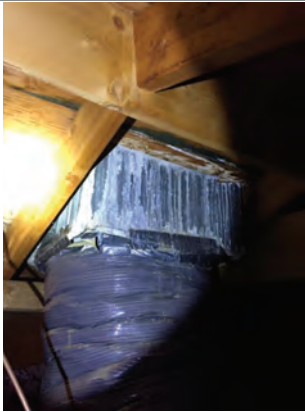
Evidence of leaking flashing around evaporative cooler.

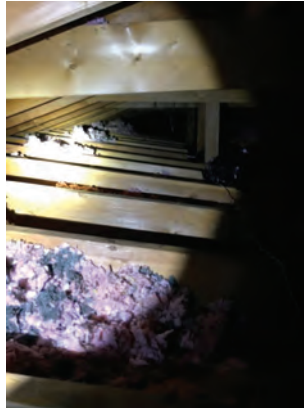
Insulation over cathedral ceiling.
Recommend additional insulation

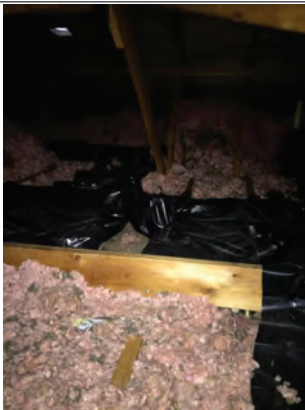
Displaced insulation
